CLINICAL CASE

ERIN DAVIS (NZROT), OCCUPATIONAL THERAPIST,
SOUTHERN REHAB, NEW ZEALAND

Enhancing positioning and maintaining skin integrity, by using Vicair cushions

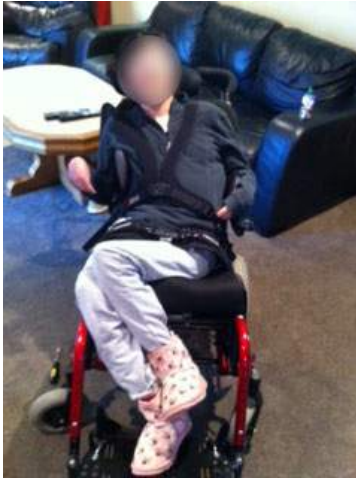
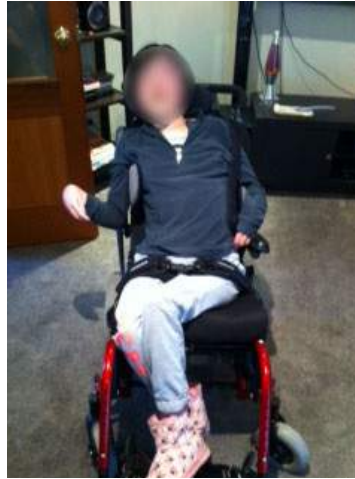
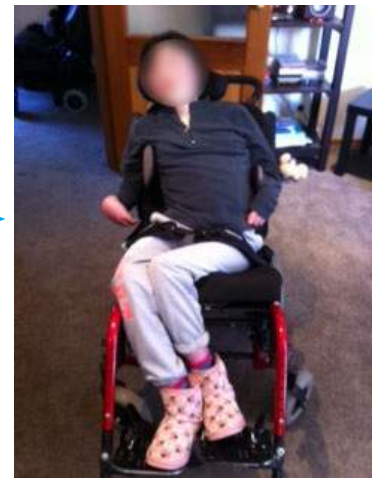
Cycle of adjustment of the seating system pre-Vicair

- A dual foam back support with contouring cube system on a solid shell was used. The system was custom contoured in the lumbar and thoracic spine area to support her lumbar lordosis and trunk rotation.
- D-shaped, curved lateral trunk supports (medium on right, large on left) off set were used to support her scoliosis.

This seating system needed to be reviewed and adjusted every 6 to 12 months and prior to starting the clinical trial it was found that it wasn't supporting her accurately. Limited further contouring was achieved but she was starting to get reddening of her skin over her left ischial tuberosity.

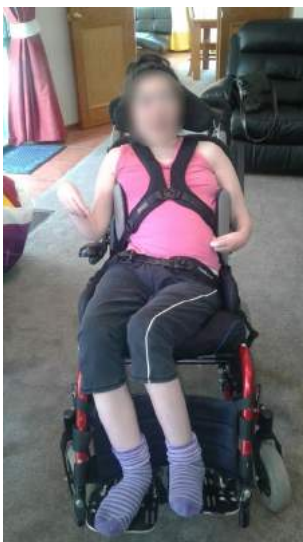
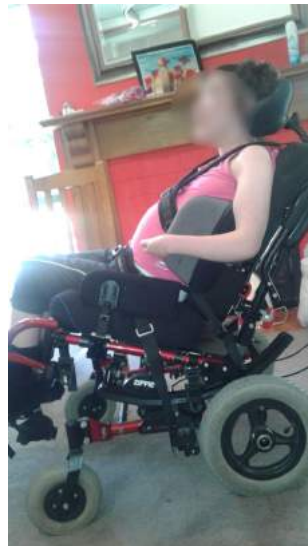
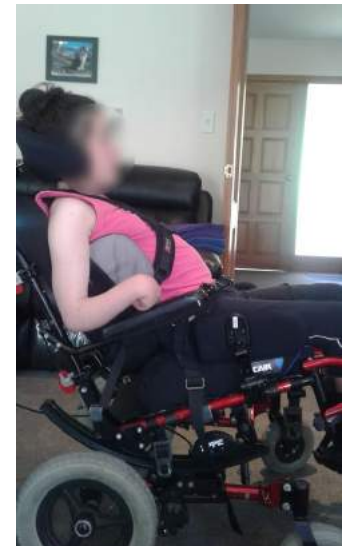
The Vicair Multifunctional back support cushion was also trialled, replacing the foam contouring on the existing back shell. It was set up with an increase in cells in the lower three compartments. It was found that Miss Y now had contact with her entire trunk and therefore gained the support in the lumbar region that she required.

It was determined that Miss Y required a system that she could immerse into to accommodate and support her rather than the system being moulded to her. Vicair cushions have immersive qualities and it was therefore decided to trial a Vicair Vector of 6cm high with an increased amount of Smartcells in the medial thigh support and right rear greater trochanter areas.

It was found that further depth was required, therefore the Vicair Vector of 10cm high was introduced. It was found to be successful at capturing Miss Y's pelvis and maintaining her skin integrity. Shortly after, the Vicair Vector O2 became available on the

Instead of sitting on top of her seating and being pushed forward, Miss Y is immersed into it. Rather than sitting on top of her cushion she is now sitting in it, therefore cradling her dislocated hips and filling all the gaps at her spine to give improved support.
